# Stress-Assisted Corrosion (SAC) in Boiler Tubes

**DOE Project #DE-FC07-01ID1443**

**To Clarify Mechanisms Involved in Stress Assisted Corrosion (SAC) of Boiler Tubes to Determine Key Parameters in its Mitigation and Control**

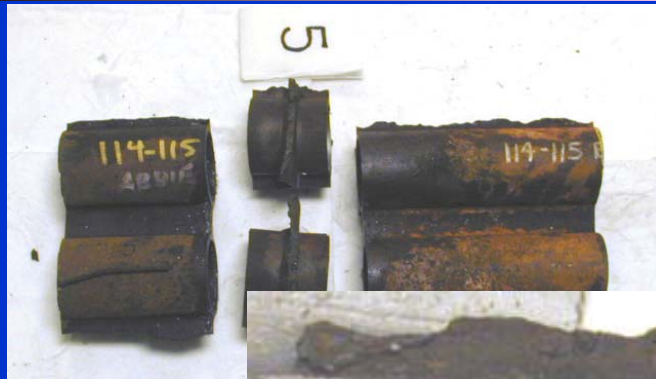
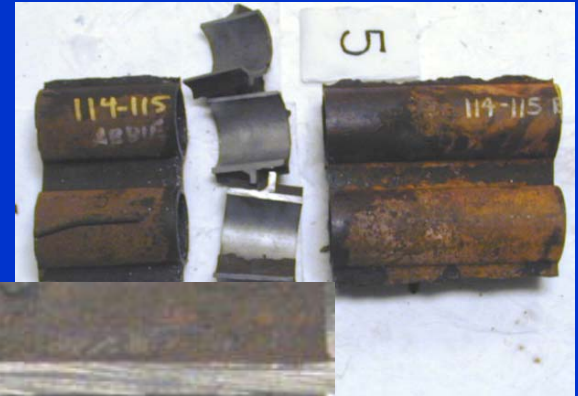
# Waterside Cracks in Waterwall Tube Near Attachment Weld

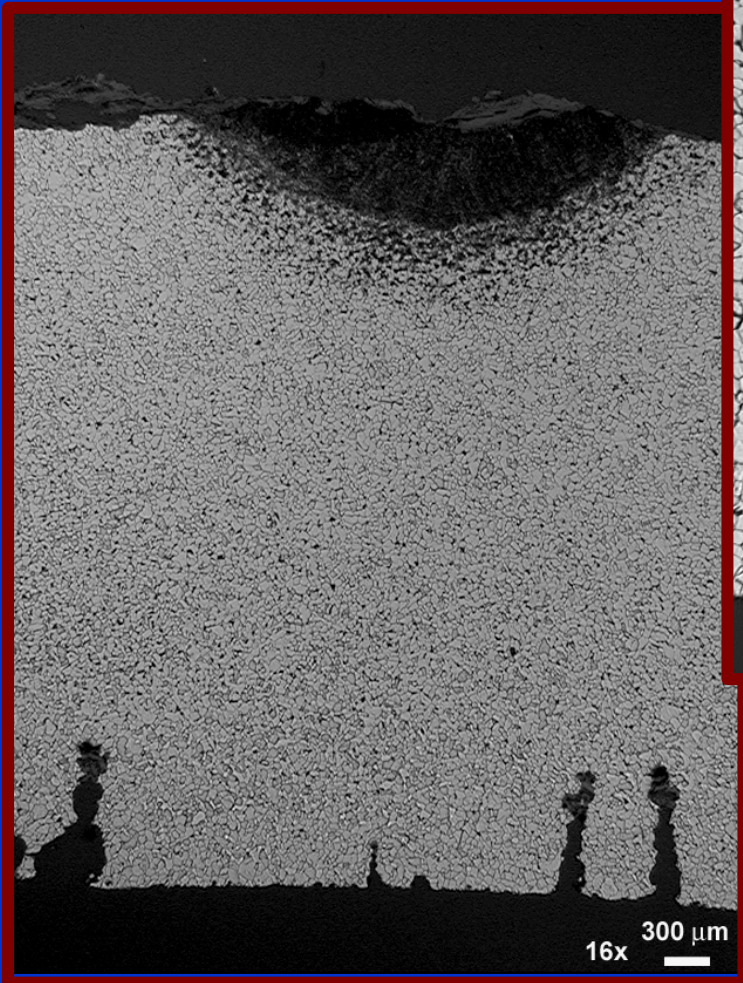
# SAC in Recovery Boiler Tubes

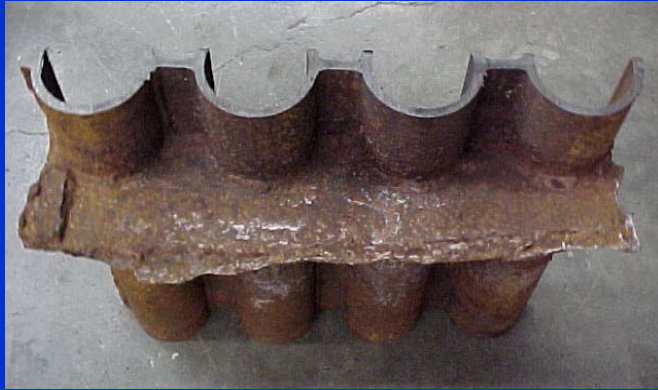
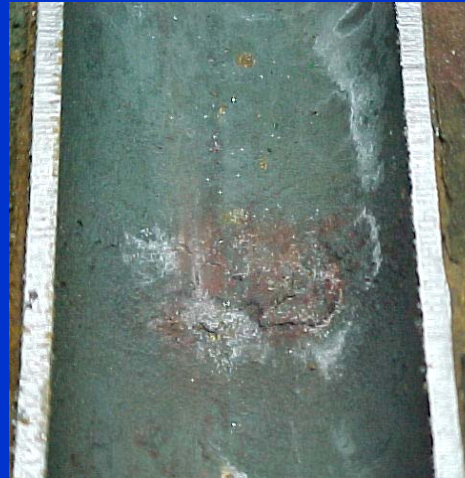
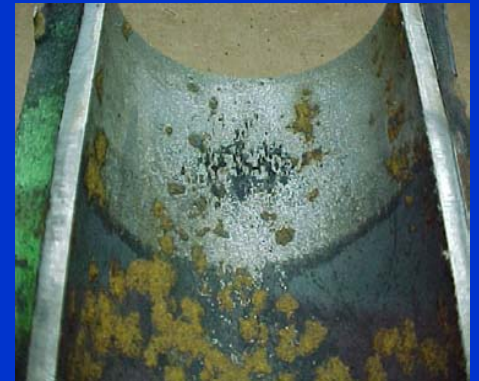
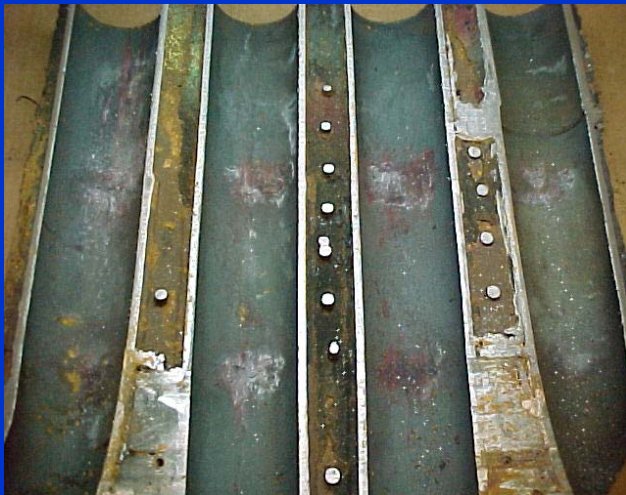
# Waterside Cracks in Waterwall Tube Near Attachment Weld

Stress Assisted Corrosion Under Welded  
Joints on Inner Surface of Waterwall  
Tubes

- **Almost 900 Linear Feet Failed Tubes were Received From Weyerhaeuser and MeadWestvaco Mills**
- **Largest Panel was 20 Feet Long by Four Tubes Wide**
- **Tubes were Sectioned and Prepared for Failure Analysis**
- **Inner Surface had Oxide Scale**
- **Scale Thickness Varied from Less than 50 Microns to More than 500 Microns at Different Areas**
- **Cracks were Generally Packed with this Oxide Film**
- **Metallography Revealed Stress Assisted Corrosion in Numerous Welded Sections**

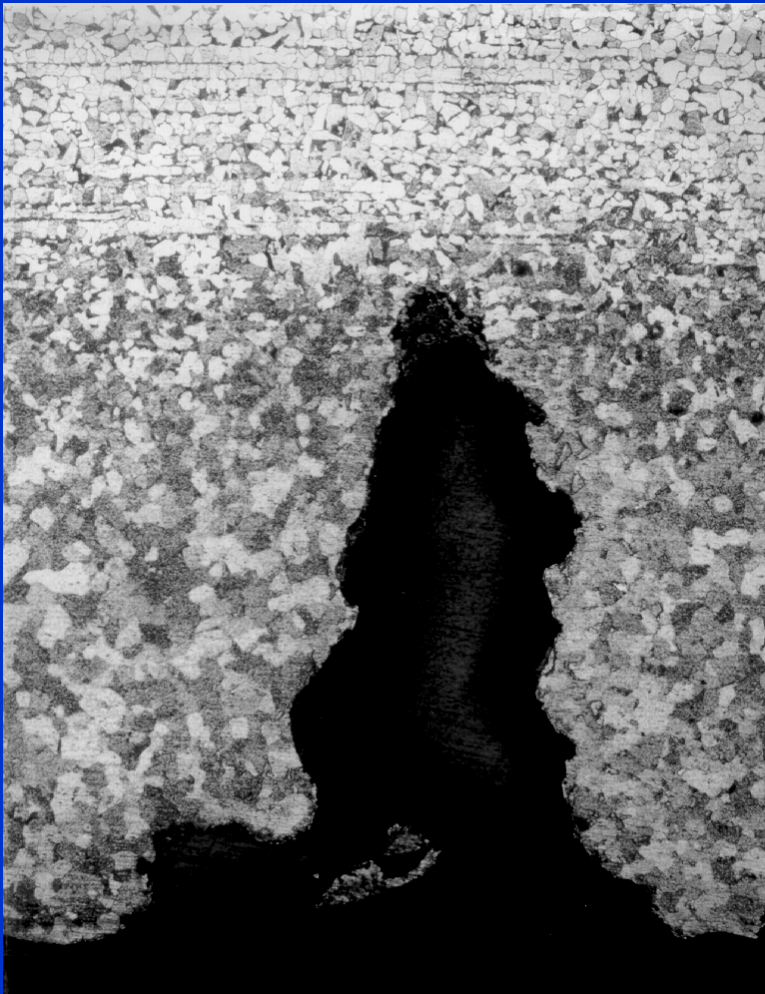
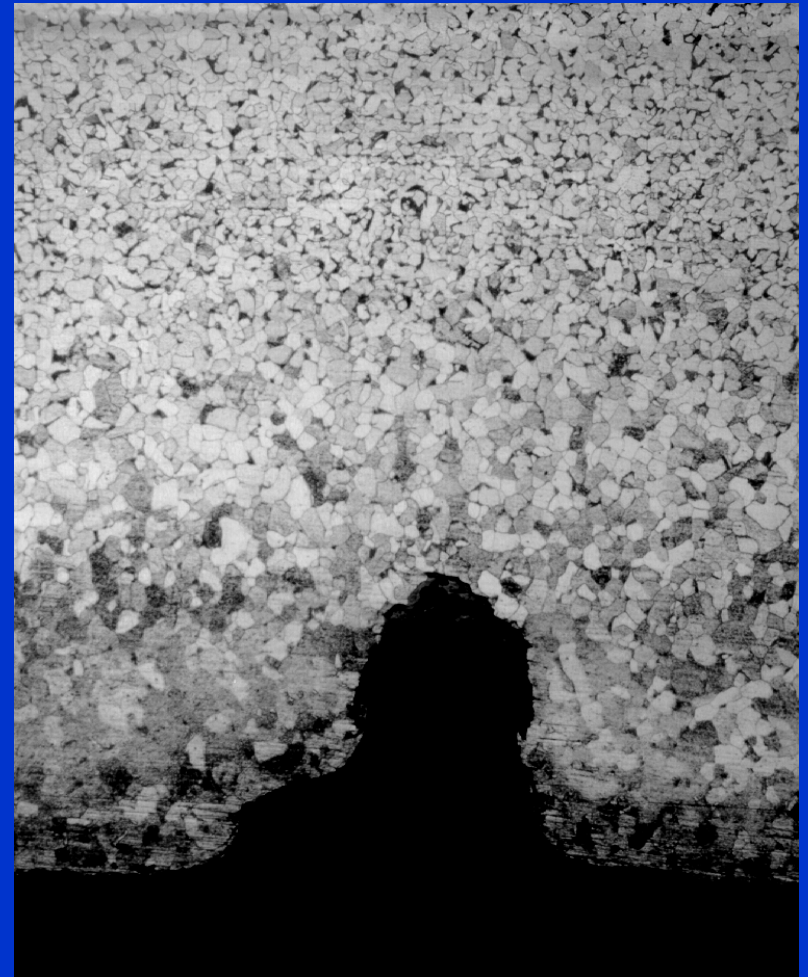
# Role of C-Steel Microstructure on initiation of Stress Assisted Cracks

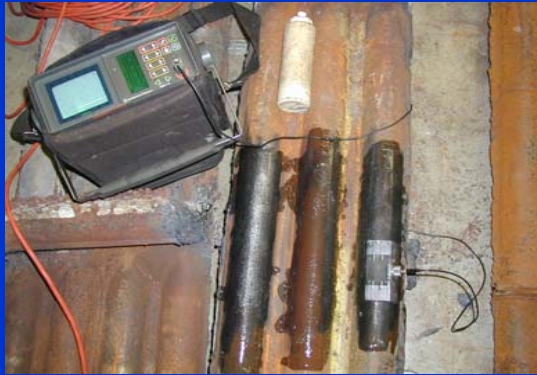
**Circumferential Wave Instrument**

- **NDE Techniques Selected were not Effective for Locating Oxide Accumulations or the Longitudinal Stress Assisted Cracking**
- **Circumferential Wave Technique has Geometry Limitations Near Most Attachment Welds**
- **Longitudinal Wave Technique Detects Only Circumferential Flaws and is Presently Insufficiently Sensitive**
- **Radiography was not Sufficiently Sensitive, Especially Near Attachments.**
- **Right-Angle Borescope Viewing could not Distinguish Oxide Accumulation**

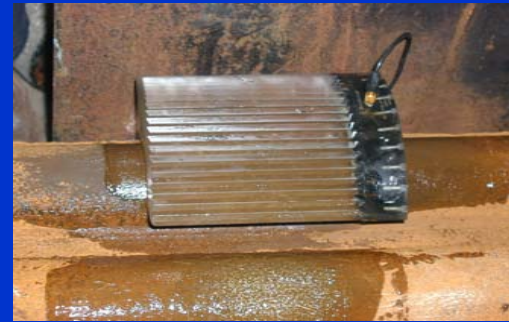
**Large Array Transducer Used for Longitudinal Wave Technique**

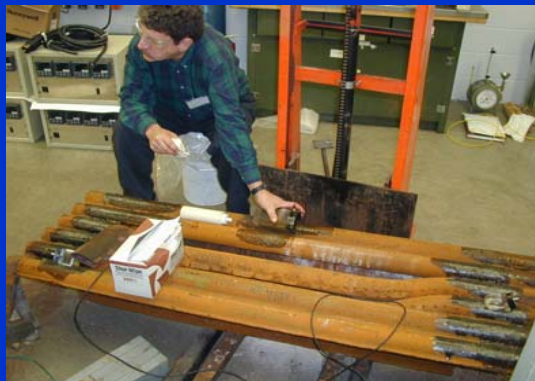
**Longitudinal Wave Technique**

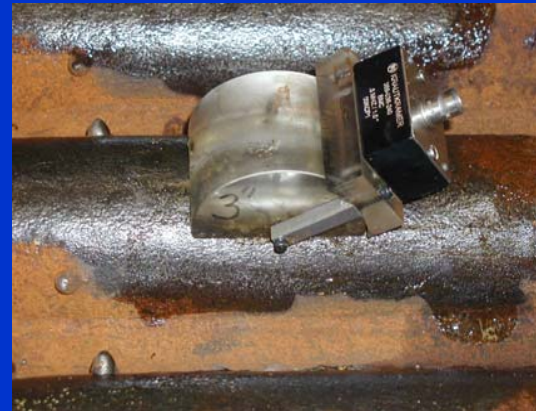
**Small Transducer Used for Longitudinal Wave Technique**
